# ILLINOIS AND MICHIGAN CANAL NATIONAL HERITAGE CORRIDOR

**Volume II: Morris**

HABS/HAER Division  
National Park Service  
U.S. Department of the Interior

### **VOLUME II: MORRIS**

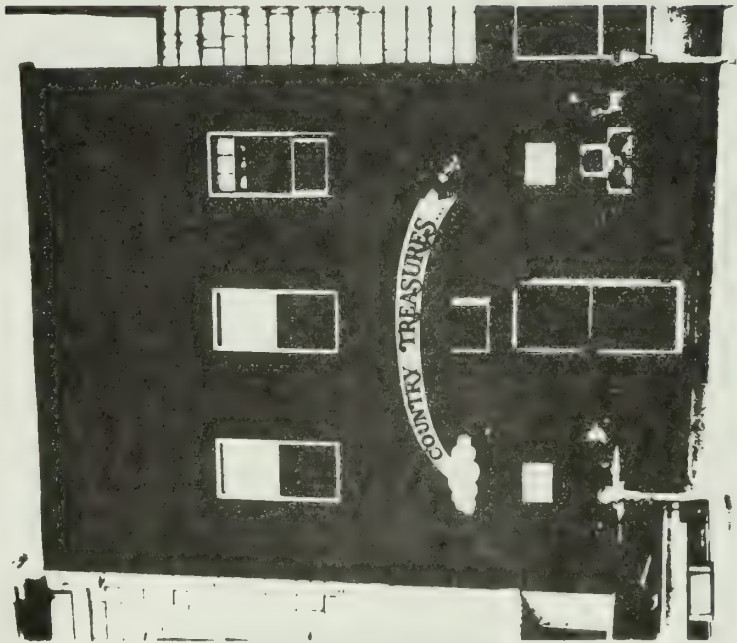
Roll 27, 22

One of the earliest structures on the block, the building is one of the few wooden commercial structures that has survived in Morris. Building is representative of the variety of commercial endeavors generated by the canal. Subsequent alterations have compromised the architectural integrity of the structure.

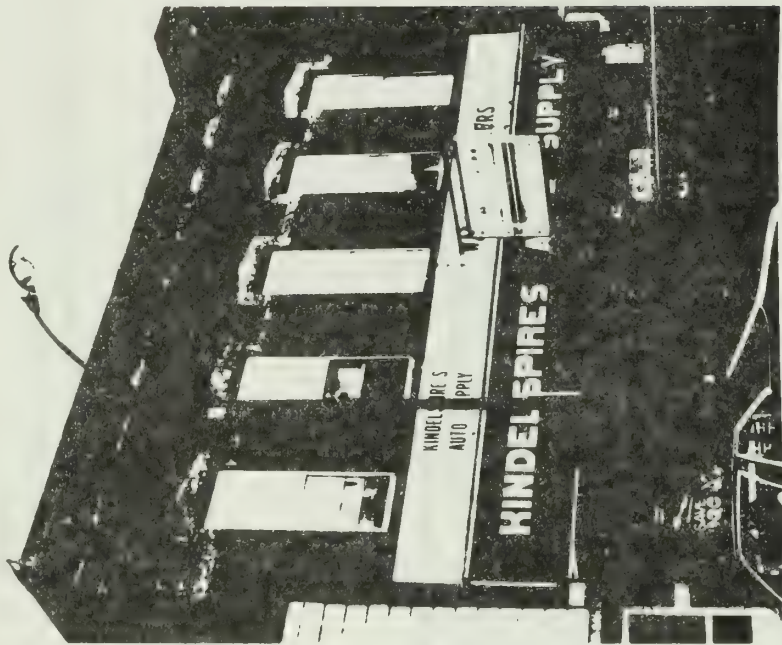
Roll 27, 20

Similar in scale and appearance to many of the area's commercial structures, the building is typical of the development that occurred in Morris in the 1800s. With few alterations, the building retains much of its historical integrity.

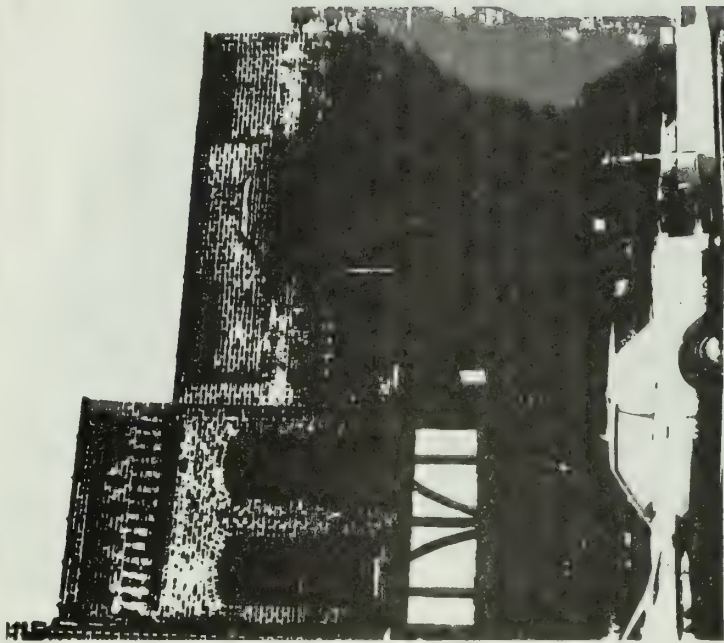
Roll 27, 36  
(left)

Element in block of mid-late 19th century commercial buildings. Compatible in scale and materials with surrounding structures; extensive storefront remodelling is not compatible with the historic architecture of the community.

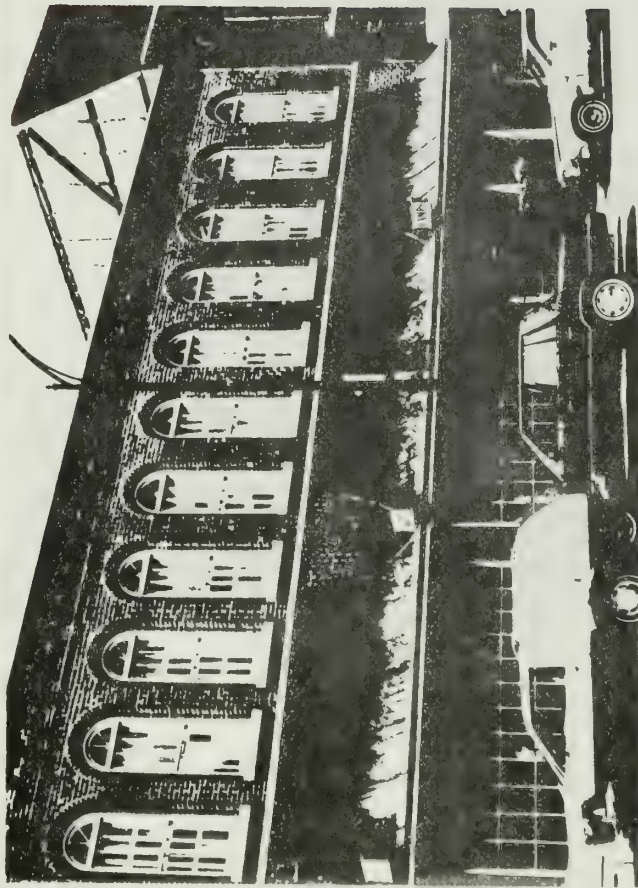
Roll 27, 34

Major element in block of mid-late 19th century commercial structures. Although it has been altered, the building retains the scale, details, and materials of surrounding historic buildings.

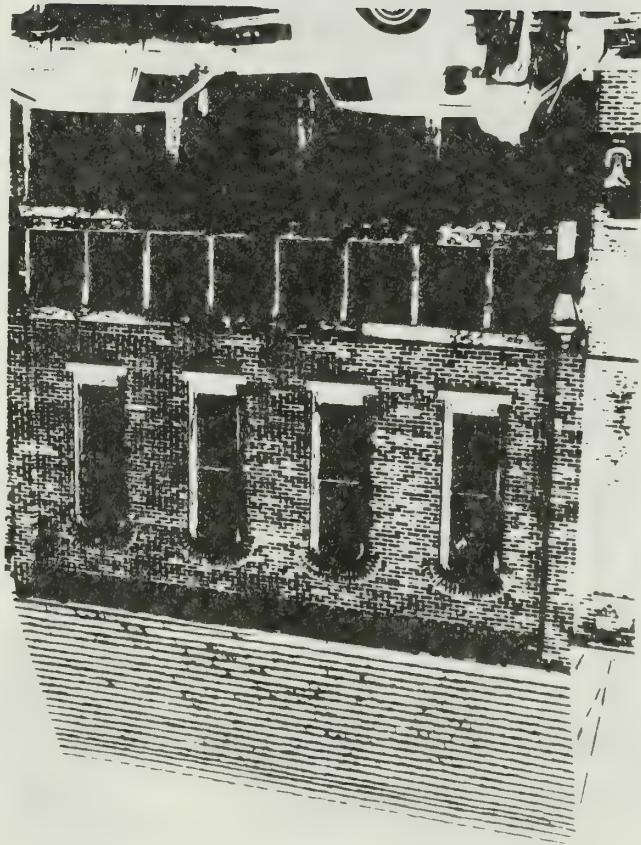
Roll 27, 35

Major commercial building significant in the development of the town as commercial center for Grundy County. Additions and alterations have completely destroyed visual historic character of the structure. Alterations have not been compatible with the historic architecture of the community.

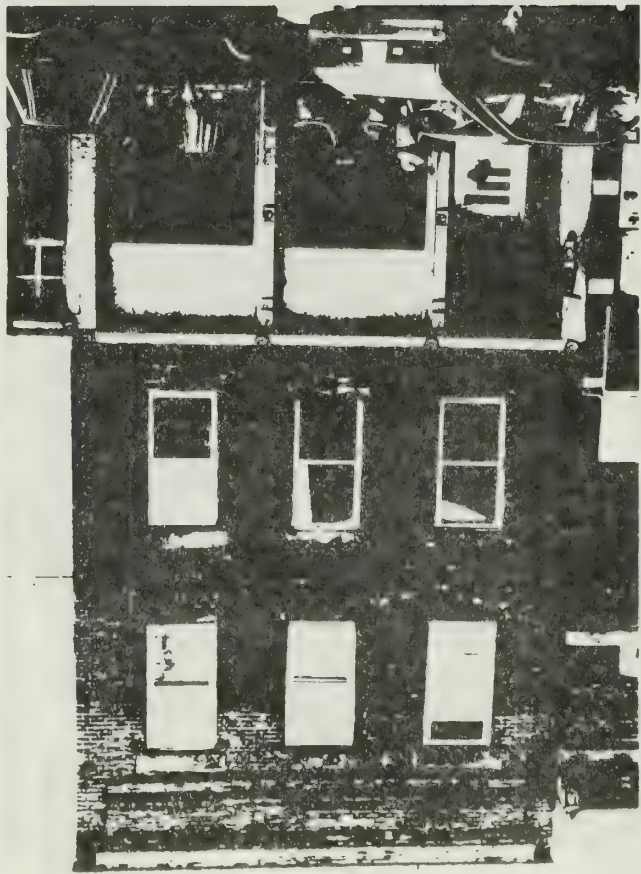
## Roll 27, 21

Major early brick commercial structure in Morris, featured with a drawing on the 1856 Doran map of Morris. Prominent location on the original principal commercial street. Compatible element in block of other 19th commercial buildings. Minimal alterations.

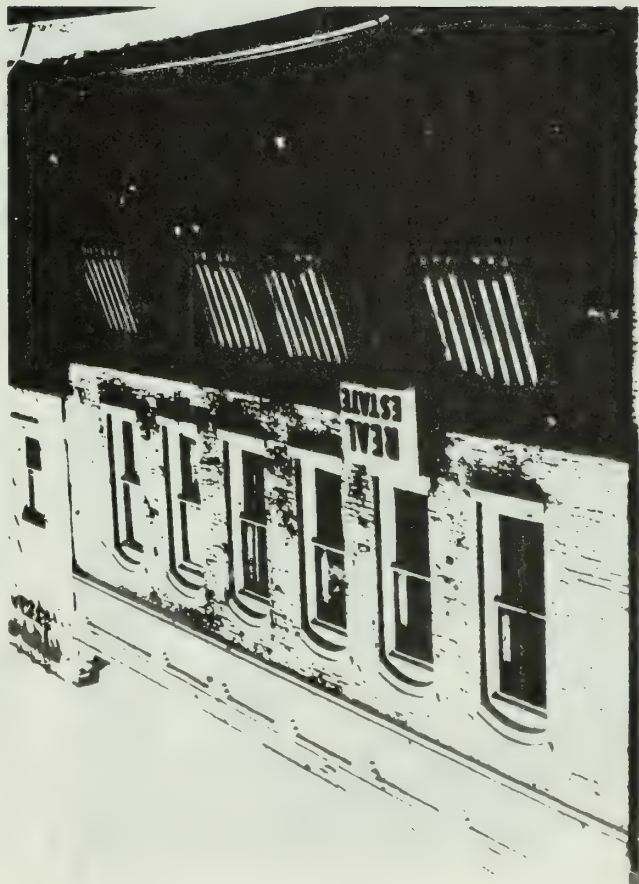
Roll 27, 32

An early commercial structure, the building illustrates the scale and variety of commercial activity generated by the I&M Canal. Located on the first major commercial street in Morris, the building is a compatible element in a block of 1850-1880 commercial structures. The architectural integrity of the structure remains virtually intact.

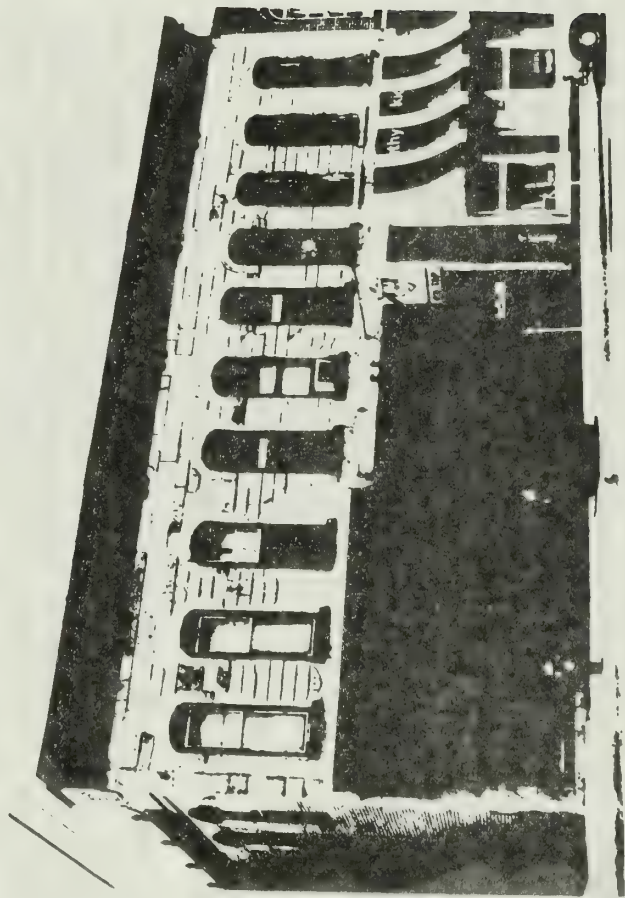
Roll 27, 33

Limestone foundation, limestone sill; sandstone front facade, tooled rusticated ashlar, regular coursing; common bond painted brick west facade. Rectangular plan with rear additions; ten-bay, three-storefront main facade. Two stories. Flat roof with parapet, stone coping on west. Three storefronts with cast iron cabled colonettes; recessed center entrances with transoms and fixed glass display windows on east and west;; west storefront has cantilevered display windows with wood kick board, wood frame six-panel door with large glass; fourth door, in fourth bay from east, leads to second story. Second story has ten one-over-one-light double-hung sash windows, segmental limestone arched lintels with deteriorated rusticated keystones, concrete lug sills; seven windows in original segmental arch wooden frames, three replacements. Significant decorative elements include: ornamental metal cornice with seven sets of paired fluted brackets with three modillions between each pair, frieze with repeated circle motif; cast iron storefront colonettes bearing manufacturer's plates, east and center manufactured in Ottawa, Ill., west by "Joliet-Humphrey". Main facade faces south; prominent corner location in central business district, two blocks from canal. Alterations include concrete block rear addition, modified west facade with wood ornament, center section has 1979 frame addition.

14 CONDITION ☐ EXCELLENT ☐ GOOD ☒ FAIR ☐ DETERIORATED ☐ RUINS

greatly deteriorated stone on south facade

Constructed at the same time as other major commercial blocks in the central business district during the period of rapid growth of the business district as the major commercial center for Grundy County. Wagonmakers and blacksmiths, the Horrie family was prominent in Morris in the 19th century. The building housed the Morris post office in the 1880s; other activities included a grocery in the 1880s-1890s; saloon, cigar factory, lodge and boarding house, 1880-1900. An example of the stone-front Italianate commercial block, the building is one of three large sandstone Italianate structures built in Morris in the late 1870s. All suffer from severe stone deterioration, but are nevertheless important as local expressions of the Italianate style.

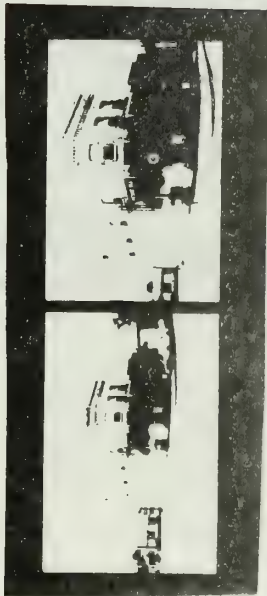
Roll 38

Limestone foundation; cut limestone plinth; common bond painted brick walls. Rectangular plan with two bays on north and four on east; canted entrance on northeast corner. Two stories. Flat roof with parapet on north and northeast corner; terracotta coping. Replacement entrance door on northeast corner; replacement windows on first story north facade; single window opening on first story east corner covered with metal panel, segmental arch of two rows of rowlocks and lug sill visible

One-over-one-light double hung metal storm/screen windows on second story, segmental arch lintels with two rows of rowlocks, painted lug sills. Paneled brick cornice with sawtooth pattern and narrow corbels. Enclosed second-story porch on south with aluminum siding and exterior wood stairs. Corner site, main entrance on northeast canted corner. Altered first story facade with unpainted weatherboard cladding and replacement windows on north; pent roof added between first and second story on north and extending onto east facade; south facade had two oversized first-story windows and central door that have been altered with cinder block and metal panels.

Example of turn-of-the-century commercial building. Corner location at west edge of central business district, one block from the canal. Relates to the commercial buildings in the block to the east in materials, style, and scale.

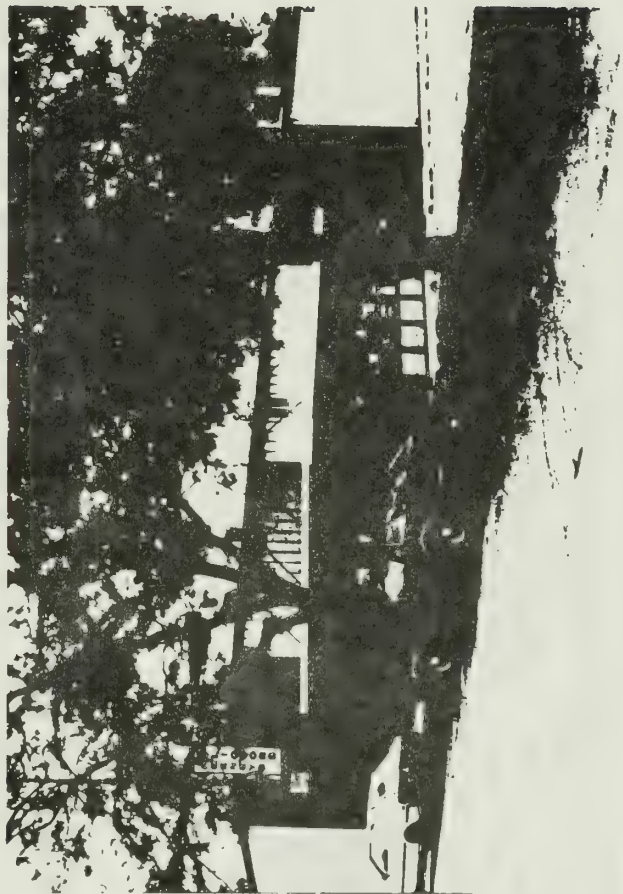
Roll 28, 35

Visual intrusion. Not compatible in materials or treatment with nearby historic commercial structures.

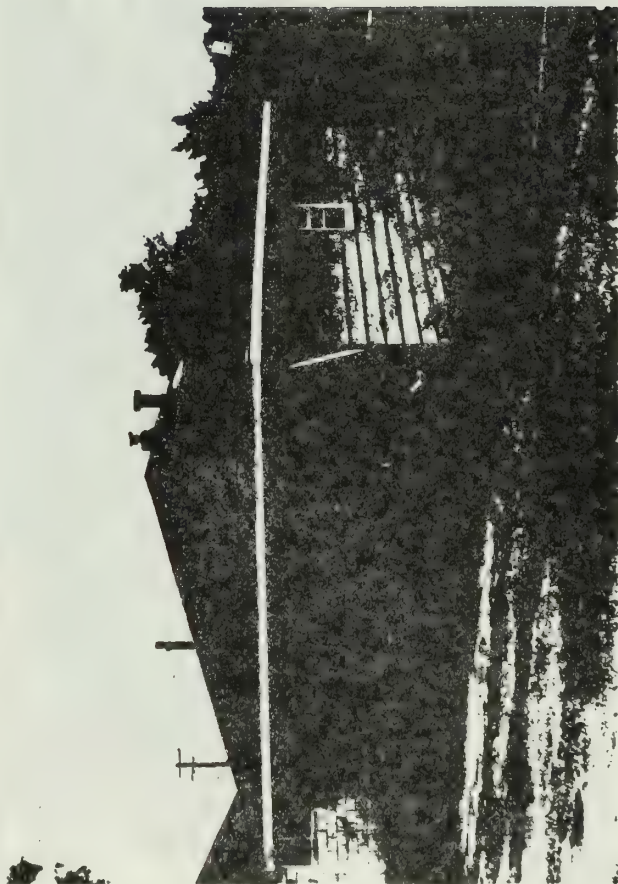
Roll 28, 34

Site is important for its proximity to the canal. Structure has no historic significance.

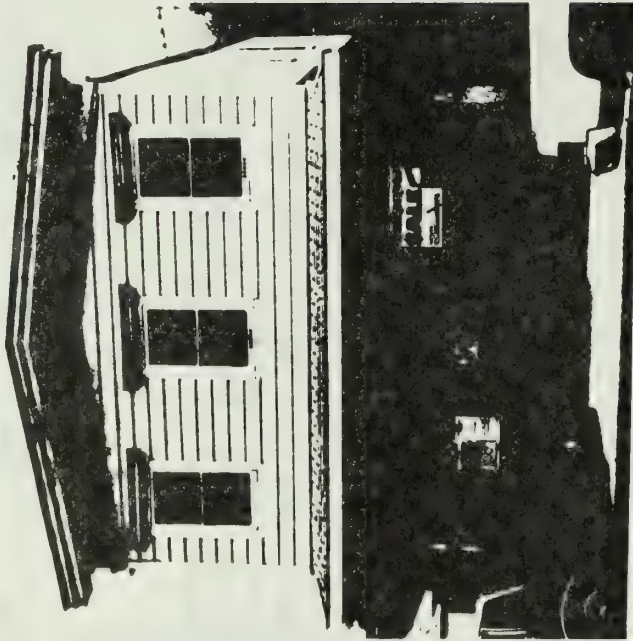
Roll 28, 33

Constructed during early period of Morris' commercial development. One of few remaining early structures in block close to canal.

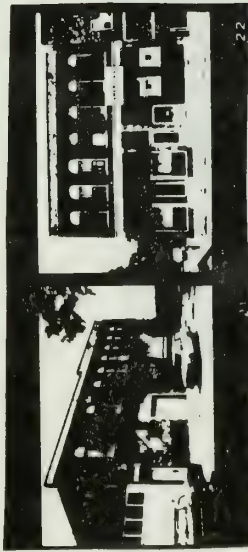
Roll 32

Similar in scale and appearance to many of the areas commercial structures, the building is typical of the development which occurred along the I&M Canal in the 1870s. Subsequent alterations and additions have compromised the architectural integrity of the structure.

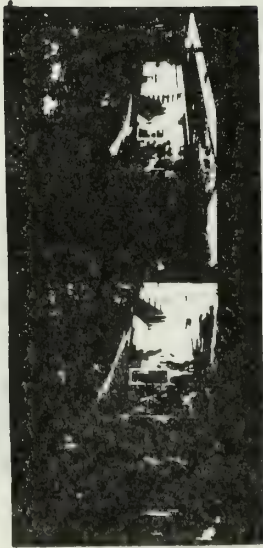
Roll 39

Example of simple front-gabled vernacular Greek Revival structure that was built during the early settlement of Morris and the building of the I&M Canal. Located one block from the canal, the building is in an area of other remaining early structures, although many have been greatly altered and there are a number of post-1940 intrusions. Identified on 1856 map of Morris as the home of Orville Cone, an early settler of Morris who was born in New York State and was a baker by trade. Alterations and additions have compromised the architectural integrity of the structure.

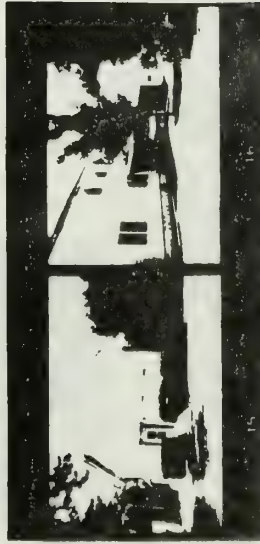
Roll 38

Similar in scale, plan and detail to Gebhard residence at 604 W. Washington St. Example of large, late Greek Revival vernacular residence built in Morris during the canal era and during the period of industrial growth in the 1870s. Located near the canal and the Gebhard brewery. Alterations and additions have compromised the architectural integrity of the structure.

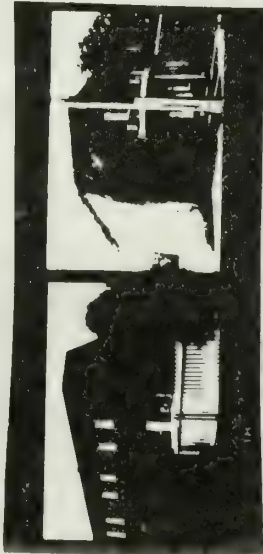
Roll 38

Part of original Gebhard brewery/residence complex. Recommend further research on the history and relationship of buildings dating from the early years of the brewery operation.

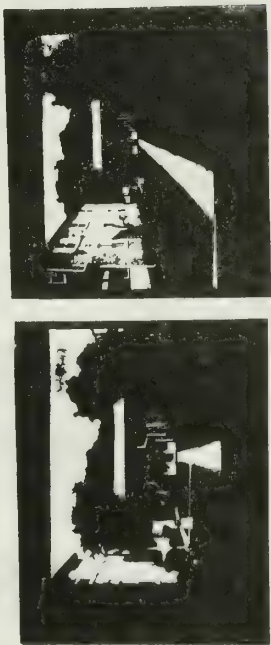
Roll 39

Foundation material not visible; wood frame construction; stucco cladding. Rectangular-shape plan; three-bay front. One and one-half stories. Side-gable roof with interlocking asphalt shingles. Two interior chimneys, one on ridge and one on north face of roof. Entrance in later, enclosed hip-roof entry porch, three cross-panel one-light wood door; one single and one paired one-over-one-light double-hung wood sash windows; four three-light frieze-band windows under eaves. Greek Revival influence. Main facade faces south; main ridge runs east-west; located on alley in mid-block of residential area; set back from other houses along West Washington St.

First record of structure on this site is ca. 1890 and is identified as stable/barn on Sanborn maps until 1927 when it first appears as a dwelling. Structure appears to be from the mid-nineteenth century and may have been moved to this location, as were a number of other early houses in this block. Example of vernacular Greek Revival architecture built in the early years of Morris' development.

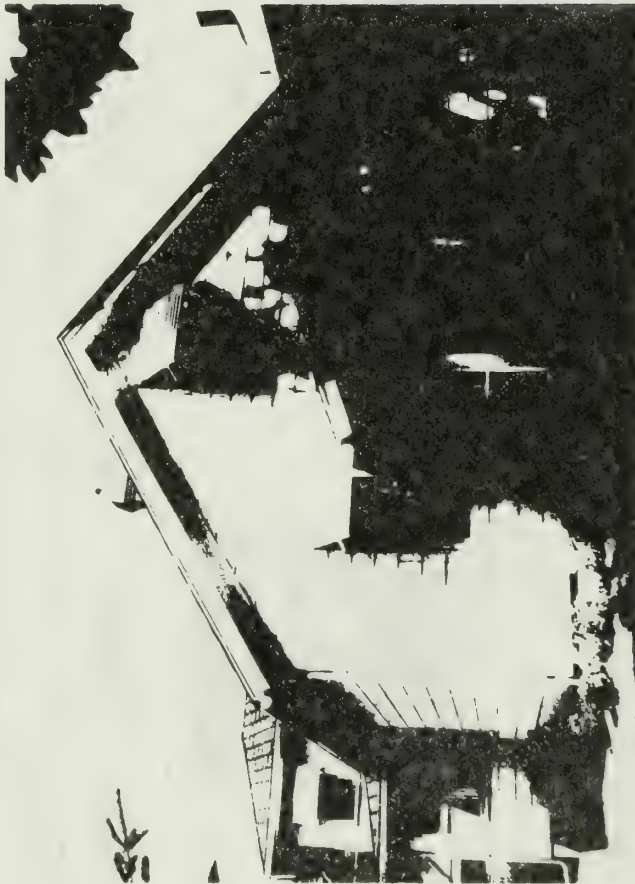
Roll 44, 36

14. CONDITION	<input type="checkbox"/> EXCELLENT	<input checked="" type="checkbox"/> GOOD	<input type="checkbox"/> FAIR	<input type="checkbox"/> RUINS	<input type="checkbox"/> DETERIORATED	<input type="checkbox"/> YES	<input checked="" type="checkbox"/> UNKNOWN
15. DANGER OF DEMOLITION? (SPECIFY THREAT)							
16. SIGNIFICANCE

Vernacular gable-roofed house from latter part of the 19th century. Possibly moved from original site to this location ca. 1910-15. Alterations and additions have compromised the architectural integrity of the structure.

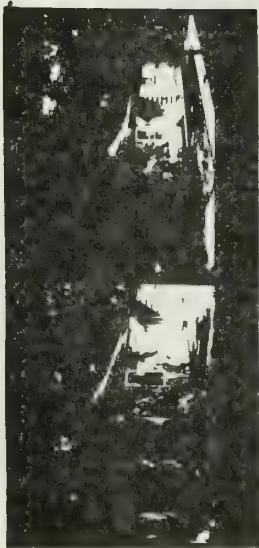
Roll 39

Limestone foundation; wood frame construction; asbestos shingle cladding. Rectangular plan with later rear and side ells; four-bay front. One and one-half stories. Front gable roof with cornice returns and parapet wall on east end above extended slope of gable on east; composition roll roofing on east face of gable, interlocking asphalt shingles on rear ell, on west face of gable, and on hip-roofed west-side entry porch. Off-center entrance with wood cross-paneled door with single large light; three one-over-one-light replacement wood double-hung sash windows, one two-over-two-light wood double-hung sash windows. Vernacular Greek Revival. Main facade faces south; main ridge runs north-south. Alterations include asbestos cladding, altered fenestration, additions.

14. CONDITION	<input type="checkbox"/> EXCELLENT <input type="checkbox"/> GOOD <input type="checkbox"/> FAIR <input checked="" type="checkbox"/> DETERIORATED <input type="checkbox"/> RUINS	15. DANGER OF DEMOLITION? (SPECIFY THREAT) <input type="checkbox"/> YES <input type="checkbox"/> NO <input checked="" type="checkbox"/> UNKNOWN
16. SIGNIFICANCE

Example of simple front-gabled vernacular Greek Revival structure that was built during the early settlement of Morris and the building of the I&M Canal. Located one block from the canal, the building is in an area of other remaining early structures, although many have been greatly altered and there are a number of post-1940 intrusions. Identified on 1856 map of Morris as the home of Orville Cone, an early settler of Morris who was born in New York State and was a baker by trade. Alterations and additions have compromised the architectural integrity of the structure.

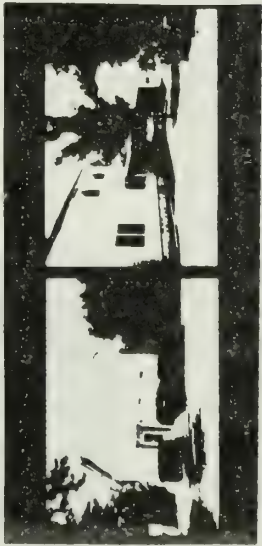
Roll 38

Rock-faced concrete block foundation; wood frame construction; aluminum siding. Rectangular plan; three-bay front. Two-story front section; one-story rear section. Low-pitched front gable roof, asphalt shingles. Interior chimney on ridge of two-story section. Vertical-paneled six-light wood door, replacement sidelights; one-over-one-light double-hung sash windows, two on first story and three on second story front facade. Open entry porch with low-pitched gabled hood, simple brackets. Main facade faces south; main ridge runs north-south; two-story modern apartment building connected by open shed-roofed porch; located half block from Gebhard Brewery, overlooking the canal. Alterations include aluminum siding and addition of apartment building.

14 CONDITION <input type="checkbox"/> EXCELLENT <input type="checkbox"/> GOOD <input checked="" type="checkbox"/> FAIR <input type="checkbox"/> DETERIORATED <input type="checkbox"/> RUINS	15 DANGER OF DEMOLITION? (SPECIFY THREAT) <input type="checkbox"/> YES <input type="checkbox"/> NO <input checked="" type="checkbox"/> UNKNOWN
--	--

Similar in scale, plan and detail to Gebhard residence at 604 W. Washington St. Example of large, late Greek Revival vernacular residence built in Morris during the canal era and during the period of industrial growth in the 1870s. Located near the canal and the Gebhard brewery. Alterations and additions have compromised the architectural integrity of the structure.

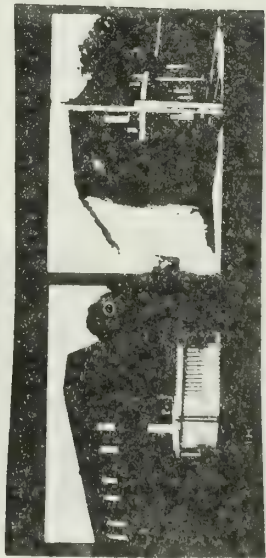
Roll 38

Part of original Gebhard brewery/residence complex. Recommend further research on the history and relationship of buildings dating from the early years of the brewery operation.
